# Pillar strength in underground stone mines in the United States

G.S. Esterhuizen\*, D.R. Dolinar, J.L. Ellenberger

National Institute for Occupational Safety and Health, PO Box 18070, Pittsburgh, PA 15236, USA

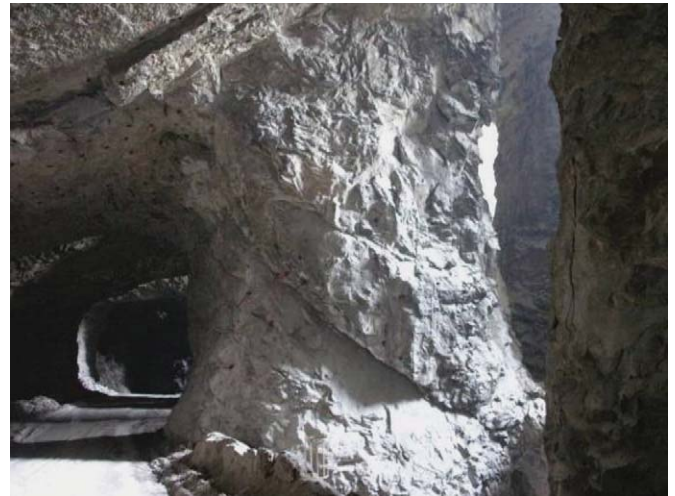
Fig. 1. Example of a pillar that is bisected by a large angular discontinuity.

Large, widely spaced discontinuities that extend from the roof to the floor or across the width of an excavation were observed in about 40% of the locations visited. These large discontinuities were logged separately because of their infrequent occurrence and their potential impact on excavation stability. The average dip was 82° and the average spacing was 7.9 m, with 72% of the spacings less than 12 m. The distribution of measured spacings follows the shape of a negative exponential distribution. The discontinuity surfaces are rough, planar and can have thin soft infill materials. These large angular discontinuities can cause a safety hazard where they intersect the roof or the pillar ribs. Also, they can have a significant impact on the strength of a pillar,

particularly if they bisect a tall, slender pillar, such as the one shown in Fig. 1.

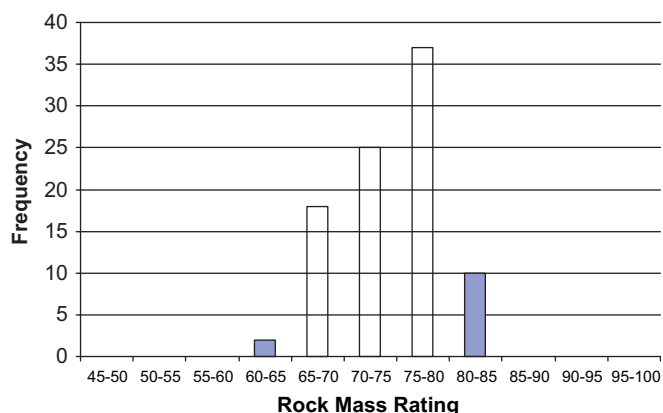
Fig. 2. Distribution of rock mass rating [9] values in underground stone mines.

The table shows that the calculated mean RMR is 74.9, which is classified as “Good” rock according to the RMR system [9]. The distribution of RMR values is shown in Fig. 2 which shows that the RMR varied between a value of 60 and 85 out of a possible 100. The fact that only about half of the mines need to regularly install roof reinforcement in the 10–15-m wide openings is evidence of the quality of the rock mass being mined.

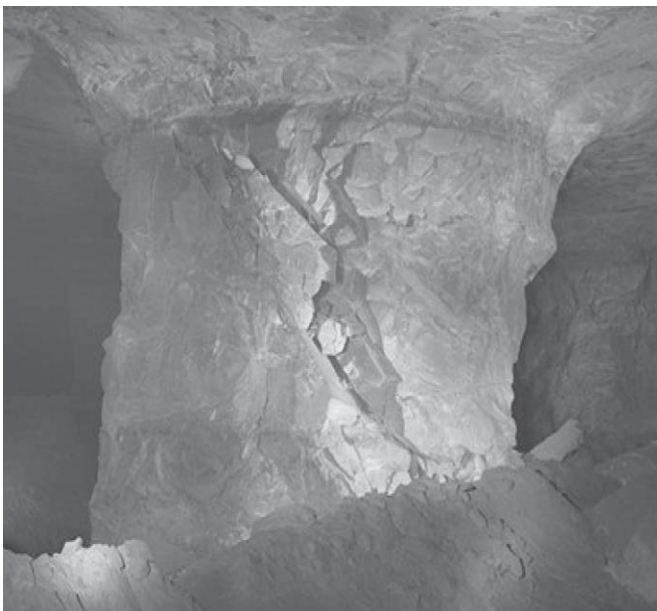
**Fig. 3.** Partially benched pillar that failed along two angular discontinuities. Width-to-height ratio is 0.58 based on full benching height and average pillar stress is about 4% of the UCS.

- (a) Large angular discontinuities that typically extend from roof-to-floor in a pillar. Sliding can occur along these discontinuities that can significantly weaken these slender pillars [18]. Of the eighteen unstable pillars observed, seven were affected by these large angular discontinuities. Fig. 3 shows a pillar that is weakened by two angular discontinuities that contributed to failure of the pillar at a relatively low pillar stress.

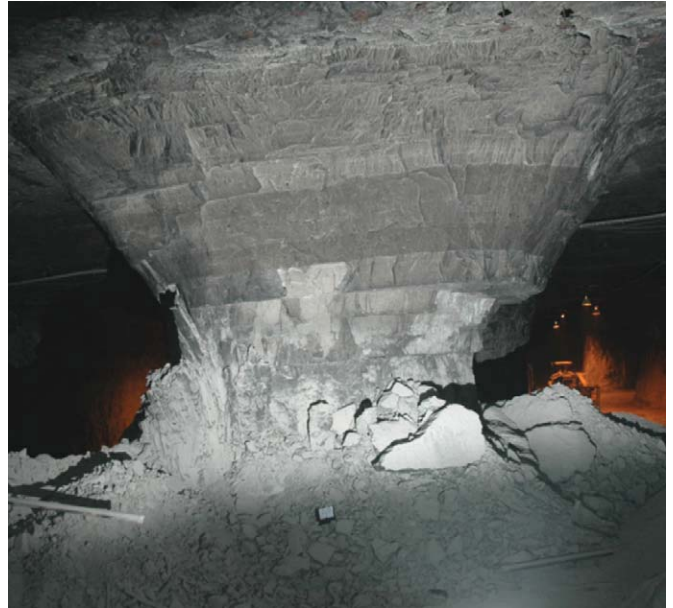
**Fig. 4.** Pillar that had an original width-to-height ratio of 1.7 failed by progressive spalling. Thin weak beds are thought to have contributed to the failure. Average pillar stress is about 11% of the UCS.

- (b) Weak bands within pillars that can extrude resulting in progressive spalling of the pillar ribs [19]. Fig. 4 shows a pillar that has been severely compromised by this mechanism of failure. It appears that moisture present in the weak beds was a contributing factor in this failure. Pillars in the immediate surrounding area appeared to be unaffected.

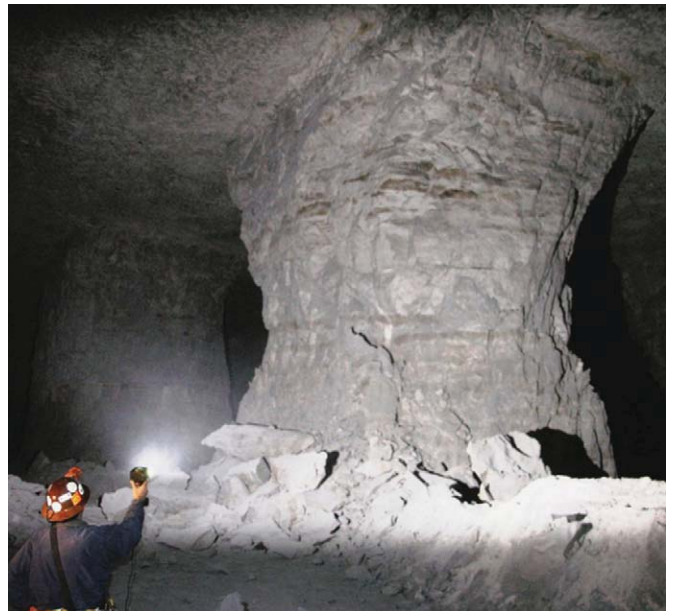
**Fig. 5.** Partially benched pillar failing under elevated stress at the edge of bench mining. Typical hourglass formation indicating overloaded pillar.

- (c) High pillar stress caused by deep cover or high extraction ratios can cause spalling of the pillar ribs [5,20–22]. It was found that spalling can initiate when the average pillar stress exceeds about 10% of the uniaxial compressive strength of the pillar material. Pillars tend to take on an hourglass shape when spalling initiates. Fig. 5 shows a pillar that has failed and taken an hourglass shape due to rib spalling. Fig. 6 shows stable pillars at one of the deeper stone mines in which minor spalling has resulted in concave pillar ribs.

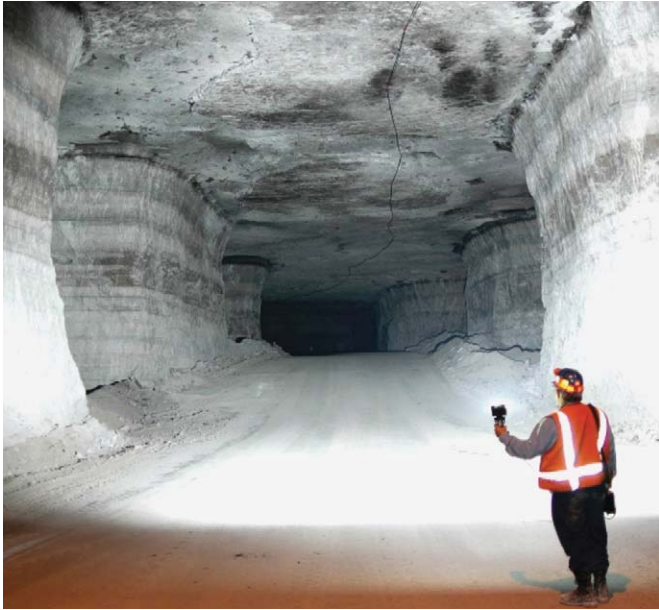
**Fig. 6.** Stable pillars in a limestone mine at a depth of cover of 275 m. Slightly concave pillar ribs formed as a result of minor spalling of the hard, brittle rock.

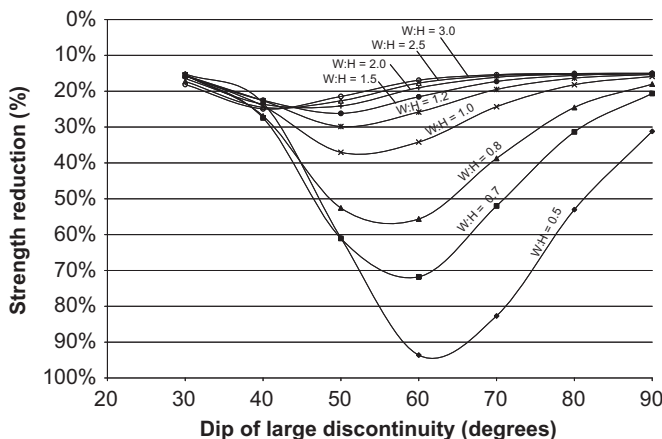
Fig. 8. Chart showing the impact of large angular discontinuities on the strength of pillars, based on numerical model results.

Various analyses were carried out in which the dip of the discontinuity was varied from 30° to 90° and the strength of the pillar was determined by simulating the gradual compression of the pillar until it reached its peak resistance and started to shed load. A series of curves were fitted to the peak resistance of each modeled pillar and are shown in Fig. 8. The results show firstly that as the discontinuity dip increases from 30° to about 60°, its impact on the pillar strength increases. When the discontinuity dip is greater than 70°, the effect starts to diminish. A vertical joint through the center of a pillar is seen to have a relatively small impact on pillar strength. These trends in the relationship between pillar strength and discontinuity dip are similar to the results obtained when testing laboratory specimens with inclined planes of weakness [24].

The width-to-height ratio is also shown to be a significant factor affecting the impact of large discontinuities. The chart shows, for example, that a pillar with a width-to-height ratio of 0.5 will suffer a 95% reduction in strength if it is intersected by a 60° dipping joint while a pillar with a width-to-height ratio of 1.0 would only suffer a 34% reduction in strength. The observation that slender pillars that are intersected by large angular discontinuities can fail when the average stress is only about 5% of the intact rock strength confirms that these large strength reductions do occur in the field and are similar to those predicted by the numerical models.

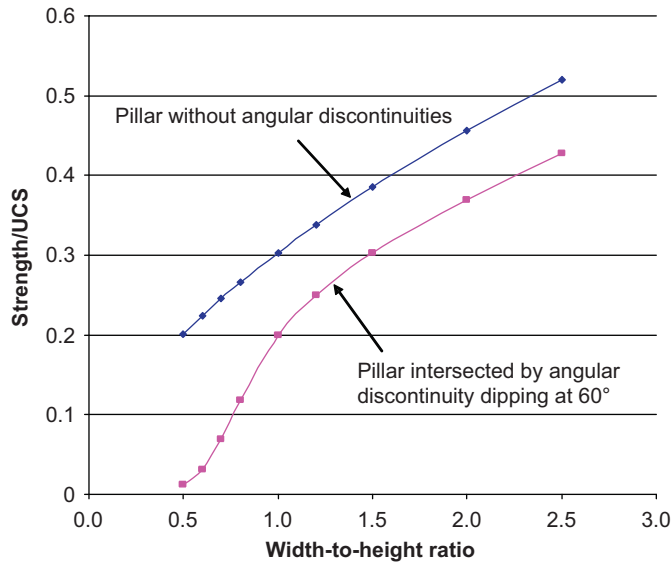
**Fig. 9.** Chart showing the predicted strength of a 14-m-wide pillar with varying width-to-height ratios, using Eq. (4). The effect of a large angular discontinuity dipping at 60° on the strength is also shown.

Eq. (4) was used to calculate the strength of a 14-m-wide pillar with varying width-to-height ratios. The results are presented in Fig. 9, which shows the strength curve for a pillar that is unaffected by large angular discontinuities and the results for a pillar that is intersected by a large discontinuity dipping at 60°. It can be seen that the discontinuity has caused a much greater reduction in pillar strength as the width-to-height ratio drops below 1.0.

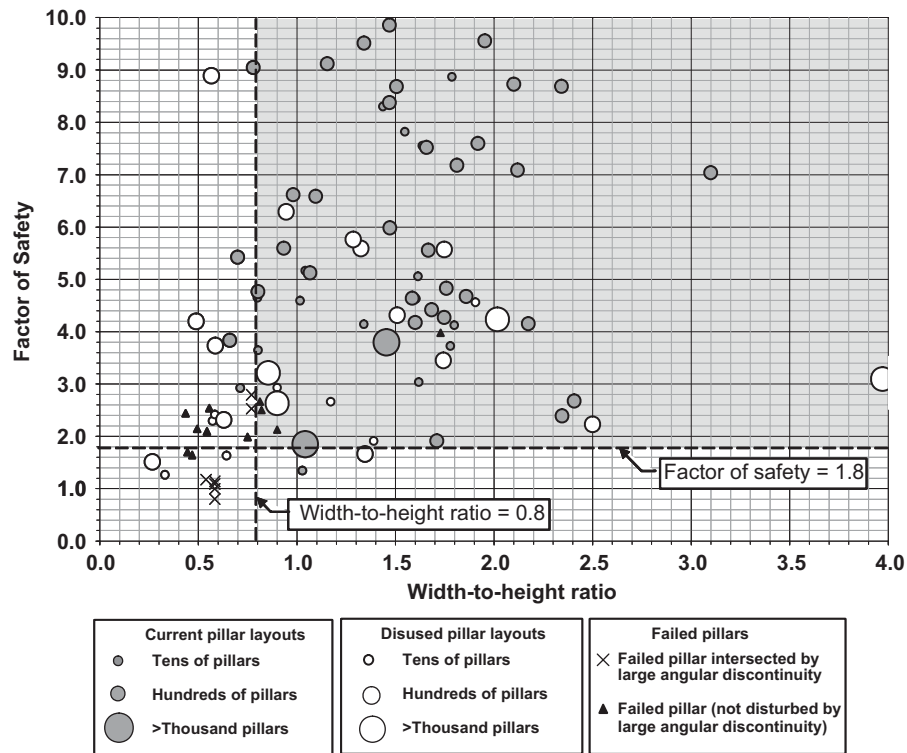
Fig. 10. Chart showing the factor of safety against width-to-height ratio using Eq. (4). Current and abandoned pillar layouts are shown as well as single failed pillars. The recommended area for pillar design is shaded.

The results show that the calculated average FOS of all the failed pillars is 2.0, which includes the cases that were intersected by large angular discontinuities. The average FOS of those pillars that are intersected by large discontinuities is 1.5. The minimum FOS for the stable layouts is 1.27, which is one of the disused layouts. It can also be seen that only one of the current pillar layouts has a FOS of between 1.0 and 1.8.

Based on the available data, it would appear there is little experience with layouts having FOS values of less than 1.8. Layouts that approach the FOS=1.8 line in Fig. 10 are typically deep layouts (> 180 m) and are subject to relatively high average pillar stresses where rib spalling can become an issue. Therefore, it is concluded that it would be prudent to design pillars that have safety factors of at least 1.8 to remain within the range of known successful layouts.

Fig. 10 shows that there has been a natural tendency for mines to avoid slender pillars. Nine of the layouts that had width-to-height ratios of less than 0.8 are no longer in use for various reasons, while only four mines included in the study are currently operating with these slender pillars. In addition, this study has shown that slender pillars are more severely affected by the presence of discontinuities than wider pillars. Studies have also shown that as the width-to-height ratio decreases below 0.8, the confining stresses within a pillar approach zero and brittle fracturing can occur throughout the unconfined pillar core [5,6,18]. The confining stress can further be reduced if low friction contact surfaces exist between the pillar and the surrounding rock. The fracturing and spalling failure mechanism is poorly understood and it seems prudent to avoid designing pillars that might fail in this manner.

Inspection of Fig. 10 reveals that a number of stable layouts exist that have large safety factors (> 3.0) and the width-to-height ratios less than 0.8. These layouts are mostly located at very shallow depths of cover, typically less than 60 m. These pillars were found to be either very narrow, as little as 4.5 m wide, or very tall, up to 38 m high. The strength and loading of narrow pillar layouts are both sensitive to small variations in the over-break, blast damage and pillar spacing. Large tall pillars have high ribs,
